# Physical improvements to the sulfuric-acid installation to enhance personnel safety

## TermoEmcali Plant

235-MW, gas-fired combined cycle located in Cali, Colombia

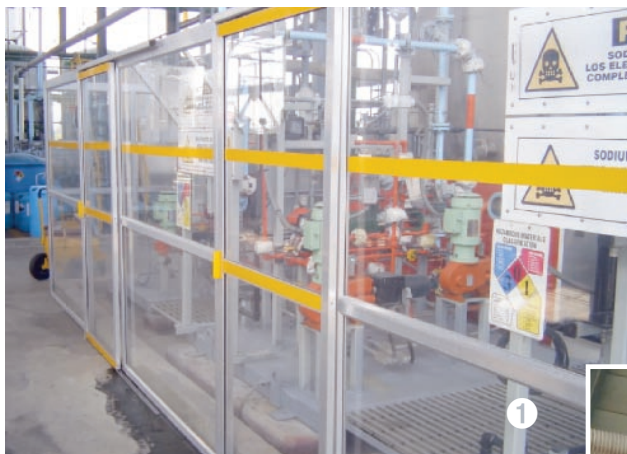
1. An 8-ft-high wall of 0.25-in.-thick clear acrylic panels was installed around the acid injection skid and its four pumps. The acrylic is supported by aluminum frames. The two access doors, the wall's top and bottom edges and the height-of-eye of an average worker are marked with yellow tape. This prevents accidents caused by forgetting that the acrylic panels are installed, a more likely problem when workers are wearing eye goggles or full face shields. The perimeter wall effectively isolates workers from potential acid spray or spills, permitting safe passage while also enabling any leak to be seen.

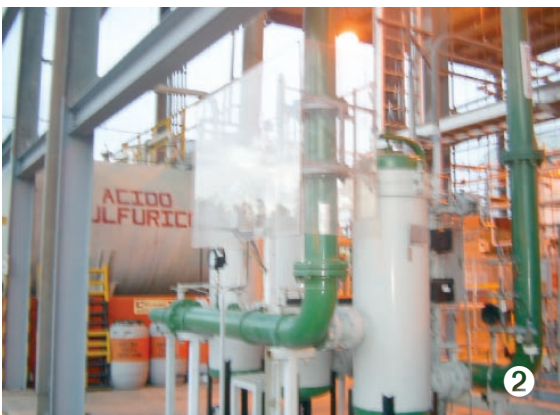
2. A location with high potential for an acid leak is the acid mixer where 98% sulfuric acid is mixed with water. A spray shield in the form of a 0.25-in.-thick acrylic box (without a top or bottom) was hung around the mixer. This shield protects workers from acid spray and limits the dispersion of sulfuric acid in event of a leak. Leak containment also reduces the amount of floor area to be cleaned.

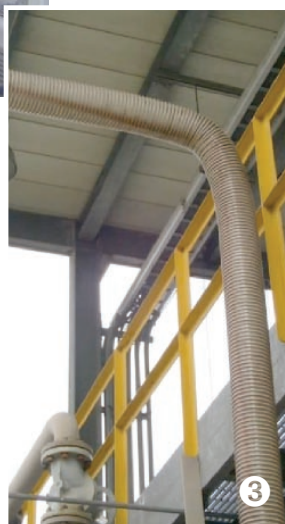
3. Flexible rubber hose was installed over the existing sulfuric acid piping from the injection skid to the mixture point. This hose protects personnel if a leak develops anywhere in the line, routes any leaked acid to a collection point, and makes visual detection of a leak during routine operator rounds easier.
