# MINNESOTA RIVER STATION

49 MW dual-fuel natural gas and oil plant that consists of an electric generation plant and a distribution substation located in Chaska, Minnesota. The facility sits on seven acres approximately 500 feet from the Minnesota River.

### Dry Air Injection System Solves Humidity-Related Electrical Problem at MMPA Minnesota River

*By Bob Burchfield – Plant Manager, MMPA Minnesota River and Faribault Energy Park*

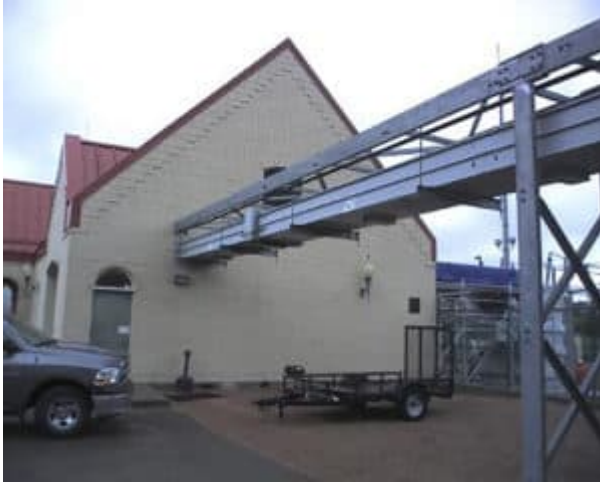
Figure 1: Normal view of bus section

Two electrical faults occurred on a 13.8 kV bus within a five-year timespan at MMPA's Minnesota River Power Station (figure 1). In both incidents, the solid copper bus and ductwork sustained extensive damage, resulting in lengthy forced outages. Figure 2 shows the burned red insulator boots at the fault location.

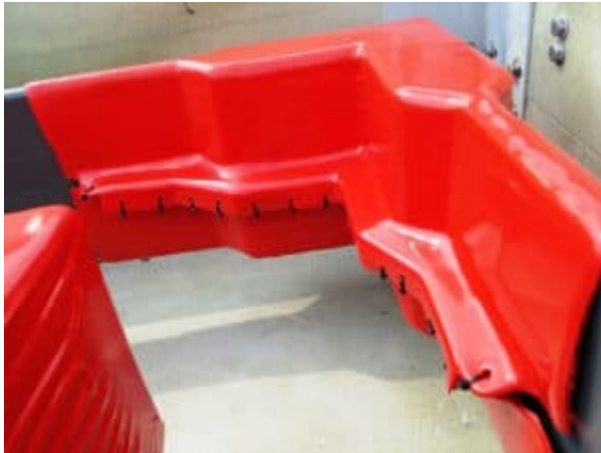
Figure 3: New style insulating boots with tie-wraps on side

While making repairs after the second incident, we noticed that the OEM had modified the replacement parts. The red insulating boots now had the tie-wraps at the sides rather than on top (figure 3). Previously, they had allowed moisture accumulated on the upper cover to drip into the seams onto exposed copper bus. The OEM had also modified the metal duct covers to create more overlap, particularly on the corners. After we had completed the repairs with improved OEM parts and added another space heater, the insulation readings still remained below acceptable values. Infrared imagery

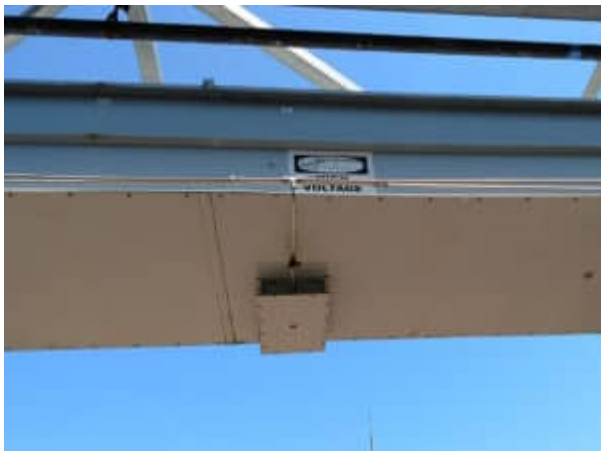
Figure 5: Stainless steel tubing with throttling valve at each heater box

In their narrative, the technicians explained how they would set equal flow to each injection point using instrument throttling valves and a flow meter to measure the incremental air-flow increase at each injection point (figure 5). At the same time, they confirmed low pressure with sufficient air flow by observing a small amount of the air exiting the duct from each vent/drain hole.

After heating the bus for a prolonged period following repairs, we found that phase-to-ground resistance readings remained below acceptable limits. We then injected dry air overnight using a makeshift regulator and hose, which significantly improved insulation and permitted the bus to be safely energized. Given the success we had with this arrangement, our technicians designed a dry-air supply system for permanent installation and wrote an operating narrative explaining multiple safeguards and interlocks to prevent over-pressure and use of a permanent dry-air injection system to prevent moisture entry. The slight positive pressure created by injecting air, they noted, is an added benefit of the injection system.

To be on the safe side, we had the technicians' proposed air-injection system reviewed by a third-party qualified engineering firm and by our management. Injecting dry air is typically reserved for iso-phase bus ducts, so there were concerns about applying this solution to a non-segregated bus duct – especially since non-segregated bus covers are fastened with screws and not necessarily designed for positive pressure. Iso-phase bus ducting, on the other hand, generally is constructed of welded tube with only one conductor per duct.

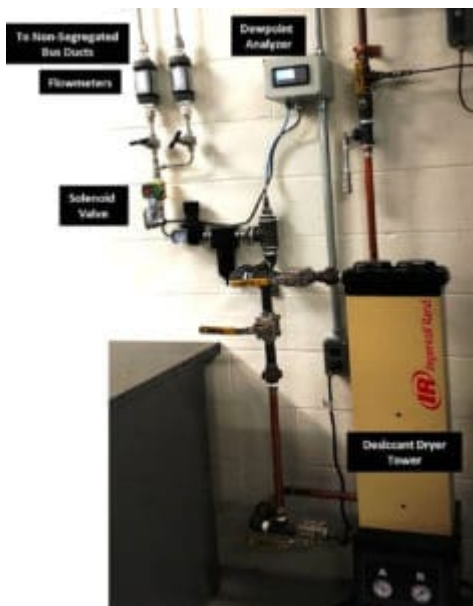
Figure 6: Dry air injection and protection equipment

- The team recognized that any malfunction of a regenerating dryer tower could allow water to enter the instrument air piping from the air compressors. We didn't completely trust the installed plant dryer tower, so the technicians proposed adding a tap to the top of the instrument air receiver tank and another dryer tower dedicated solely to the non-segregated bus duct (figure 6).
- We also procured and installed a dedicated dew-point

analyzer that we programmed to shut off the air-supply solenoid at a predetermined set point. The normal dew-point temperature downstream of two dryer towers is very low, so we opted for a conservative shutoff set point of 0° F. Part of our logic in being this conservative was that the dew point remains relatively constant in the new system, so a change of any appreciable amount could indicate a problem.

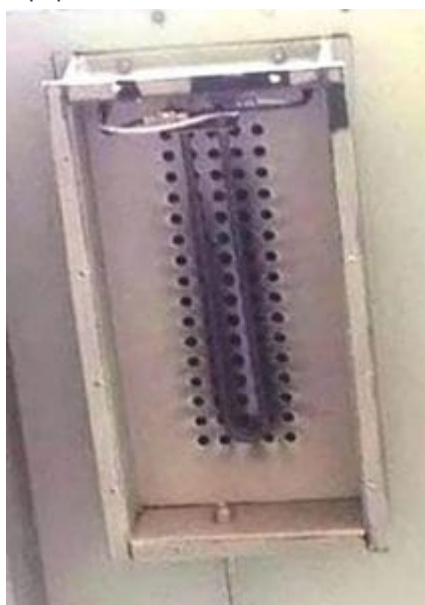
Figure 7: Perforated heater box with air injection tubing penetration

- Since the air is injected at each space heater box located below the bottom bus cover, dry air enters the bus duct through perforated holes above the heater. If water reaches this box from the air supply, it has a last chance of removal through the bottom screened hole (figure 7).
