# MINNESOTA RIVER STATION

### Dry Air Injection System Solves Humidity-Related Electrical Problem at MMPA Minnesota River

*By Bob Burchfield – Plant Manager, MMPA Minnesota River and Faribault Energy Park*

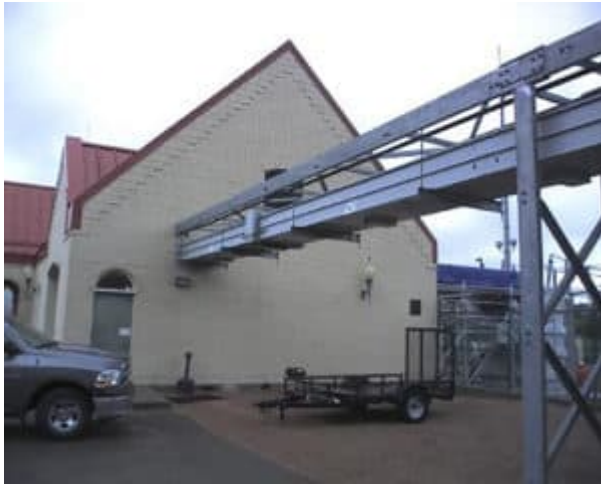
Two electrical faults occurred on a 13.8 kV bus within a five-year timespan at MMPA's Minnesota River Power Station (figure 1). In both incidents, the solid copper bus and ductwork sustained extensive damage, resulting in lengthy forced outages. Figure 2 shows the burned red insulator boots at the fault location.

Figure 1: Normal view of bus section

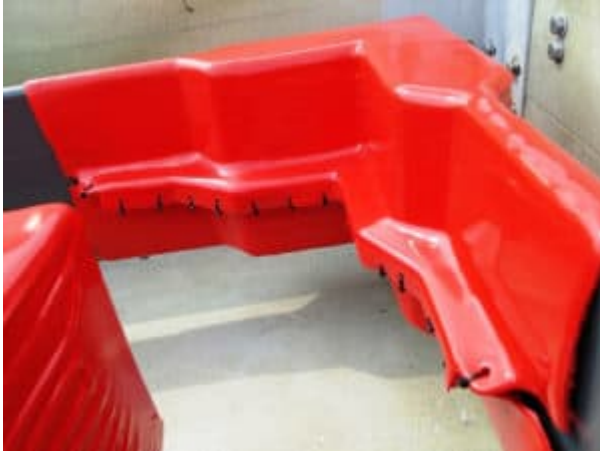
While making repairs after the second incident, we noticed that the OEM had modified the replacement parts. The red insulating boots now had the tie-wraps at the sides rather than on top (figure 3). Previously, they had allowed moisture accumulated on the upper cover to drip into the seams onto exposed copper bus. The OEM had also modified the metal duct covers to create more overlap, particularly on the corners. After we had completed the repairs with improved OEM parts and added another space heater, the insulation readings still remained below acceptable values. Infrared imagery

Figure 3: New style insulating boots with tie-wraps on side

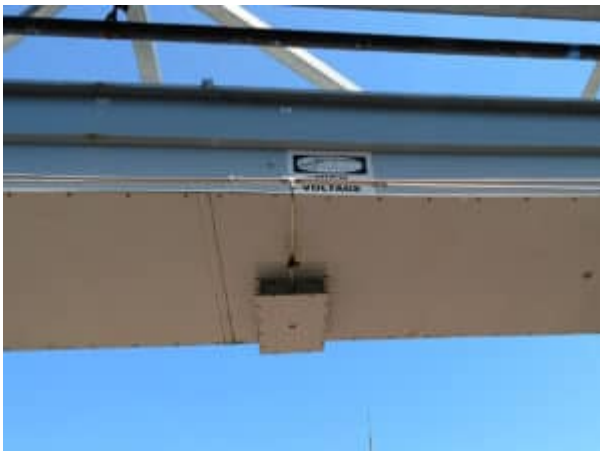
Figure 5: Stainless steel tubing with throttling valve at each heater box

In their narrative, the technicians explained how they would set equal flow to each injection point using instrument throttling valves and a flow meter to measure the incremental air-flow increase at each injection point (figure 5). At the same time, they confirmed low pressure with sufficient air flow by observing a small amount of the air exiting the duct from each vent/drain hole.

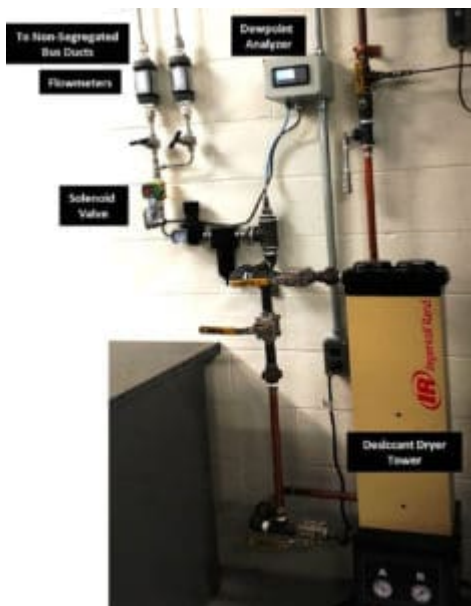
Figure 6: Dry air injection and protection equipment

- The team recognized that any malfunction of a regenerating dryer tower could allow water to enter the instrument air piping from the air compressors. We didn't completely trust the installed plant dryer tower, so the technicians proposed adding a tap to the top of the instrument air receiver tank and another dryer tower dedicated solely to the non-segregated bus duct (figure 6).
- We also procured and installed a dedicated dew-point

analyzer that we programmed to shut off the air-supply solenoid at a predetermined set point. The normal dew-point temperature downstream of two dryer towers is very low, so we opted for a conservative shutoff set point of 0° F. Part of our logic in being this conservative was that the dew point remains relatively constant in the new system, so a change of any appreciable amount could indicate a problem.

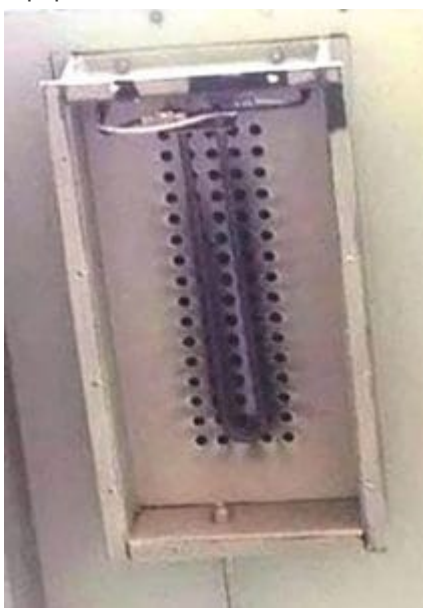
Figure 7: Perforated heater box with air injection tubing penetration

- Since the air is injected at each space heater box located below the bottom bus cover, dry air enters the bus duct through perforated holes above the heater. If water reaches this box from the air supply, it has a last chance of removal through the bottom screened hole (figure 7).
