# MINNESOTA RIVER STATION

### Dry Air Injection System Solves Humidity-Related Electrical Problem at MMPA Minnesota River

*By Bob Burchfield – Plant Manager, MMPA Minnesota River and Faribault Energy Park*

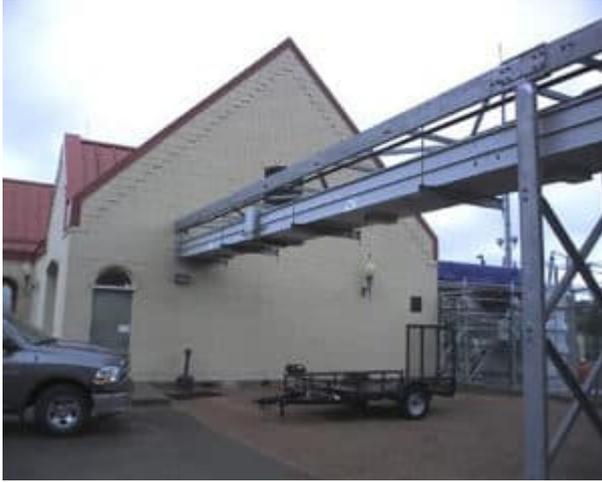
Figure 1: Normal view of bus section

Two electrical faults occurred on a 13.8 kV bus within a five-year timespan at MMPA's Minnesota River Power Station (figure 1). In both incidents, the solid copper bus and ductwork sustained extensive damage, resulting in lengthy forced outages. Figure 2 shows the burned red insulator boots at the fault location.

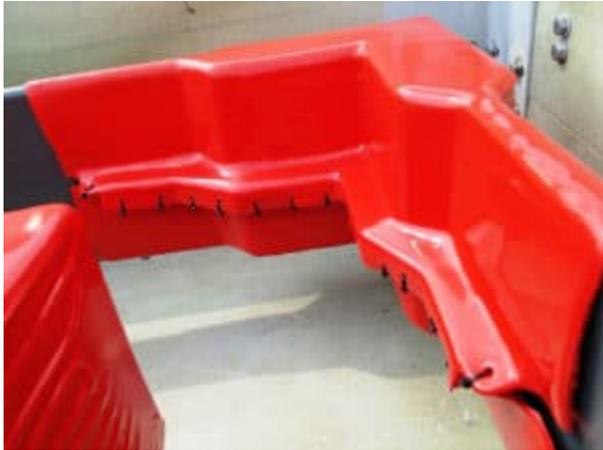
While making repairs after the second incident, we noticed that the OEM had modified the replacement parts. The red insulating boots now had the tie-wraps at the sides rather than on top (figure 3). Previously, they had allowed moisture accumulated on the upper cover to drip into the seams onto exposed copper bus. The OEM had also modified the metal duct covers to create more overlap, particularly on the corners. After we had completed the repairs with improved OEM parts and added another space heater, the insulation readings still remained below acceptable values. Infrared imagery

Figure 3: New style insulating boots with tie-wraps on side

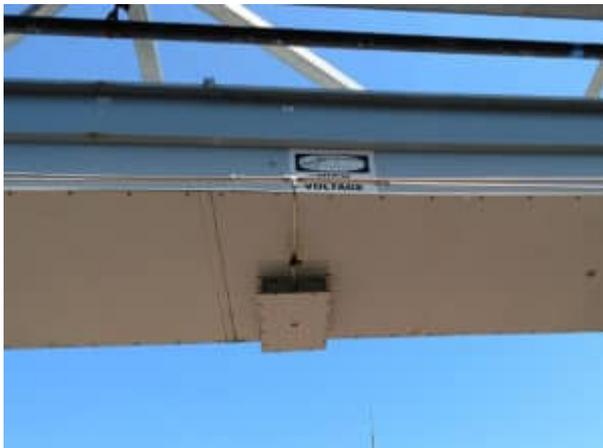
In their narrative, the technicians explained how they would set equal flow to each injection point using instrument throttling valves and a flow meter to measure the incremental air-flow increase at each injection point (figure 5). At the same time, they confirmed low pressure with sufficient air flow by observing a small amount of the air exiting the duct from each vent/drain hole.

Figure 5: Stainless steel tubing with throttling valve at each heater box

After heating the bus for a prolonged period following repairs, we found that phase-to-ground resistance readings remained below acceptable limits. We then injected dry air overnight using a makeshift regulator and hose, which significantly improved insulation and permitted the bus to be safely energized. Given the success we had with this arrangement, our technicians designed a dry-air supply system for permanent installation and wrote an operating narrative explaining multiple safeguards and interlocks to prevent over-pressure and use of a permanent dry-air injection system to prevent moisture entry. The slight positive pressure created by injecting air, they noted, is an added benefit of the injection system.

To be on the safe side, we had the technicians' proposed air-injection system reviewed by a third-party qualified engineering firm and by our management. Injecting dry air is typically reserved for iso-phase bus ducts, so there were concerns about applying this solution to a non-segregated bus duct – especially since non-segregated bus covers are fastened with screws and not necessarily designed for positive pressure. Iso-phase bus ducting, on the other hand, generally is constructed of welded tube with only one conductor per duct.

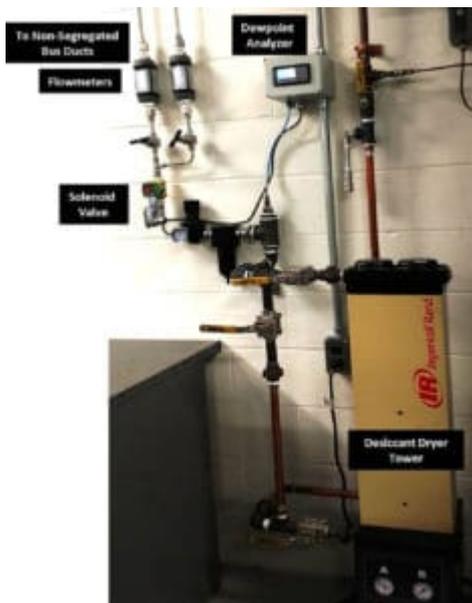
- The team recognized that any malfunction of a regenerating dryer tower could allow water to enter the instrument air piping from the air compressors. We didn't completely trust the installed plant dryer tower, so the technicians proposed adding a tap to the top of the instrument air receiver tank and another dryer tower dedicated solely to the non-segregated bus duct (figure 6).
- We also procured and installed a dedicated dew-point

analyzer that we programmed to shut off the air-supply solenoid at a predetermined set point. The normal dew-point temperature downstream of two dryer towers is very low, so we opted for a conservative shutoff set point of 0° F. Part of our logic in being this conservative was that the dew point remains relatively constant in the new system, so a change of any appreciable amount could indicate a problem.

Figure 6: Dry air injection and protection equipment

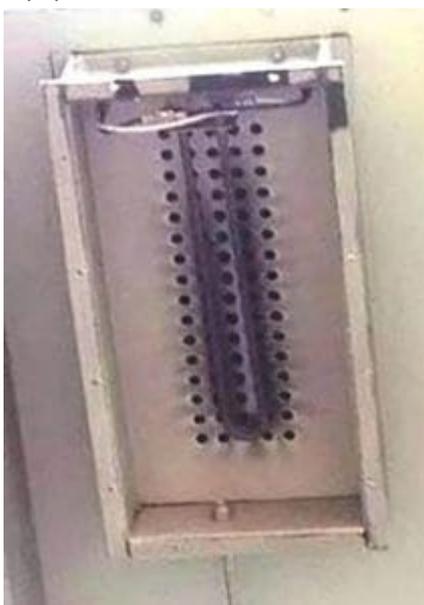
- Since the air is injected at each space heater box located below the bottom bus cover, dry air enters the bus duct through perforated holes above the heater. If water reaches this box from the air supply, it has a last chance of removal through the bottom screened hole (figure 7).

Figure 7: Perforated heater box with air injection tubing penetration
